Manhole Inspection Summary

Manhole # S65A1_005MH

Insp Date: **5/15/08 1:35 PM**

Location Address: **2200 Broening Hwy.**

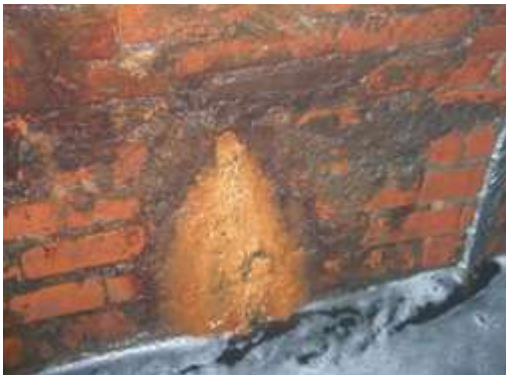
Defect 3

Condition: ☐ Sound ☐ Cracked ☐ Root Intrusion ☒ **Deteriorated** ☒ **Leaks** ☒ **Debris**

infiltration @ bench wall due to small hole.

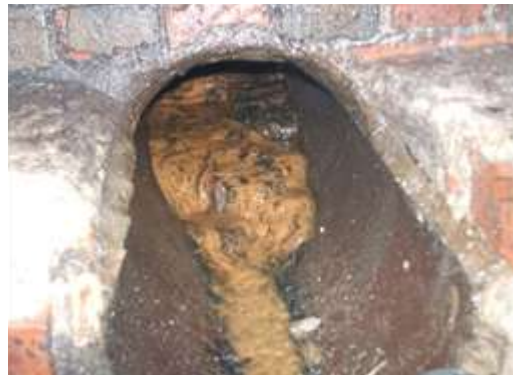
Defect 2

clogged pipe @ 9 oclock

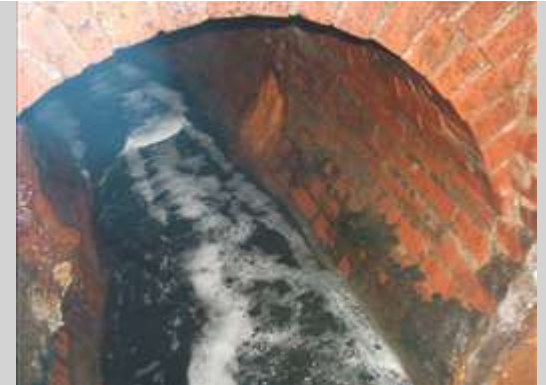
12 O'Clock Outflow

Pipe Height: **42** (in.) Rod Only
Pipe Material: **Concrete** ☐ Pipe Lined
Invert Depth: **28.00** (ft.) Flow Characteristics: **Slow**
Deposits: ☐ None ☐ Mud ☒ **Sludge** ☐ Debris ☐ Grease
Silt Depth: **0.5** (in.) Deposits Extent: **Light**
Infiltration: **None** Pipe Seal Cond: **Sound**

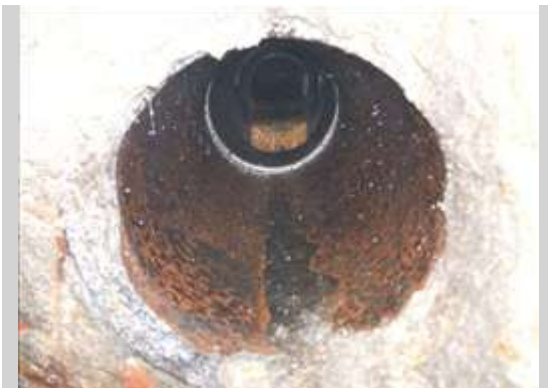
2 O'Clock Inflow

Pipe Height: **8.4** (in.) Rod Only
Pipe Material: **Clay** ☐ Pipe Lined
Invert Depth: **17.42** (ft.) Flow Characteristics: **Fast**
Deposits: ☐ None ☐ Mud ☒ **Sludge** ☐ Debris ☐ Grease
Silt Depth: **0.5** (in.) Deposits Extent: **Light**
Infiltration: **None** Pipe Seal Cond: **Sound**

Drop: **Inside** **Rod Only**
Angled: Reading: **24.58** (ft.)
Inv Depth: **24.58** (ft.)

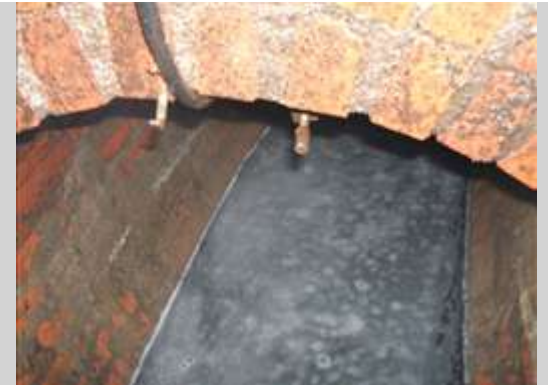
6 O'Clock Inflow

Deposits: ☐ None ☐ Mud ☒ **Sludgy** ☐ Debris ☐ Grease

Silt Depth: **0.5** (in.) Deposits Extent: **Light**

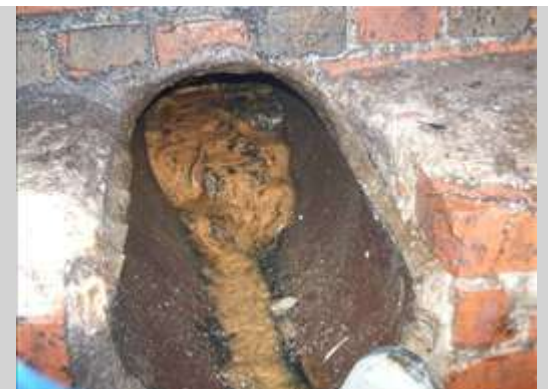
9 O'Clock Inflow

Deposits: ☐ None ☐ Mud ☒ **Sludgy** ☐ Debris ☐ Grease

Silt Depth: **3** (in.) Deposits Extent: **Medium**
